**COASTAL BASIN
SALEM-MONTVILLE, CONNECTICUT**

**BARNES RESERVOIR DAM
CT 00236**

**PHASE 1 INSPECTION REPORT
NATIONAL DAM INSPECTION PROGRAM**

MAY 1979

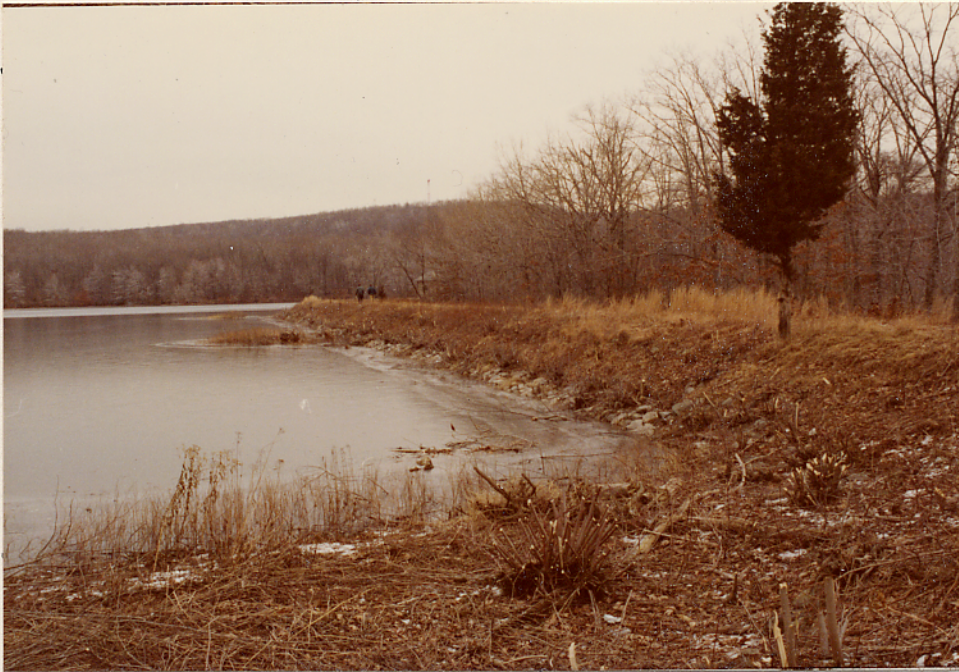
2. Upstream Slope. The upstream face of the dam was stone armored to slightly above the water level at the time of the inspection. The armor protection provided was in general 12-inch cobbles and in some locations requires reshaping. Above the riprap, the slope was grassed and covered with brush. The upstream face was sloped approximately 2H:1V. At the time of the inspection, the reservoir pool was about 5.5 feet below the crest of the embankment. Photos C-1, 2 and 3 illustrate the condition. See Appendix B for typical sketches. On April 9, 1979, the upstream slope had been cleared of brush, except for the section to the right of the spillway. Two trees remain on the upstream slope after clearing (approximately Stas. 0+50 and 7+00). A few isolated erosion gullies, up to 1 ft. wide and 6 in. deep, were found on the upstream slope near Stas. 1+50 and 9+50. A small erosion scarp was found above the riprap on the upstream slope in some areas. In general, the erosion on the upstream slope can be described as slight to moderate.

C-1 UPSTREAM SLOPE OF MAIN EMBANKMENT - LOOKING FROM RIGHT ABUTMENT

- d. Because freeboard allowances for this dam are minimal and the present stone armor is irregular, dislodged or missing, designs should be developed for the installation of suitable erosion protection to supplement the existing riprap. Preparation of these designs should make maximum use of the existing stone.

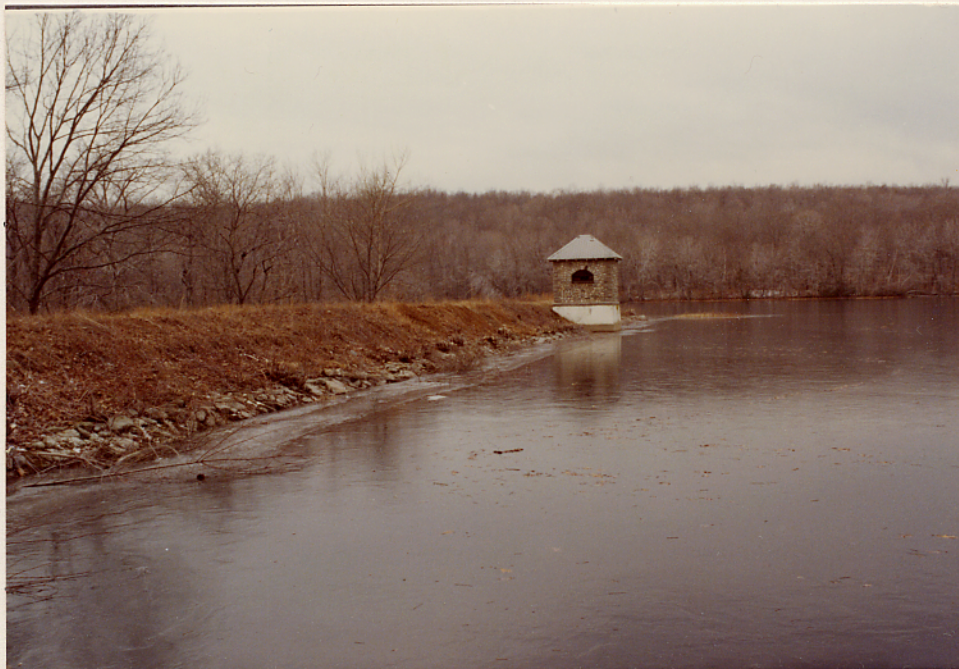
C-2 UPSTREAM SLOPE OF MAIN EMBANKMENT - LOOKING FROM LEFT ABUTMENT

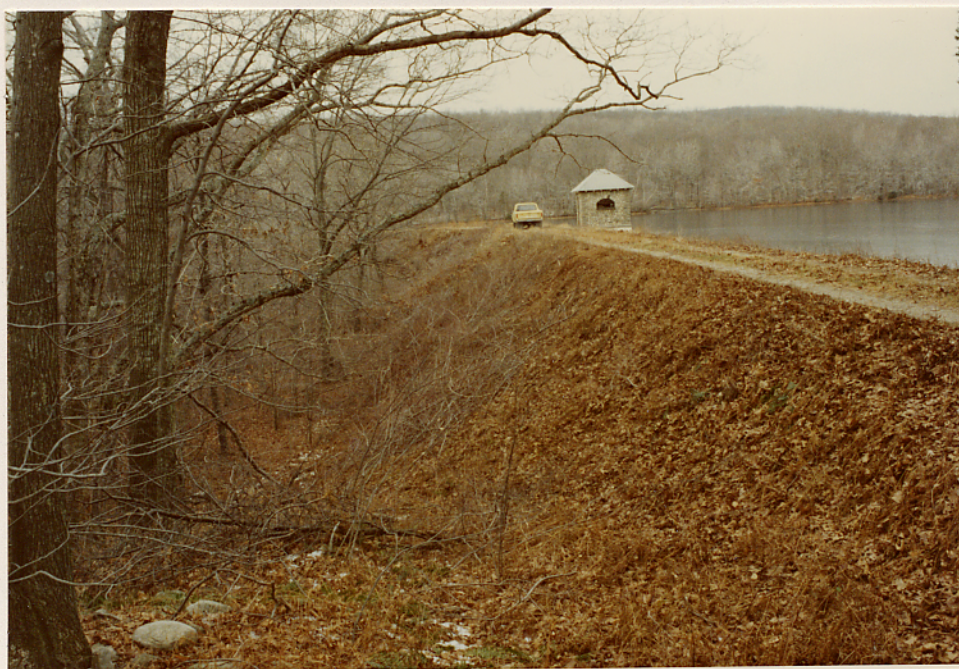
3. Downstream Slope. The downstream slope of the dam is typically 1.5H:1V and is grassed (See Photos C-4,5,6). The slope was covered extensively with vegetation which was being cleared and trimmed at the time of the inspection. On April 9, 1979, the downstream slope has been largely cleared of brush, except for the section to the right of the spillway. A few large trees were found growing within 10 ft. of the toe of the slope. A few isolated erosion gullies were found, similar to the upstream slope. A discharge of flowing water was observed at about Sta. 6+60 approximately 12 ft. from the toe of the slope. The discharge area was about 1 ft. in diameter. The discharge contained trace amounts of sand and freshly deposited sand was found surrounding the area. Representatives of the Owner and plans indicate a toe drain outlet is located in this area and the discharge may be associated with the toe drain outlet buried below the ground surface; however, no direct evidence of the existence of a drain outlet was visible in the field.

C-4 DOWNSTREAM SLOPE OF MAIN EMBANKMENT - LOOKING FROM LEFT ABUTMENT

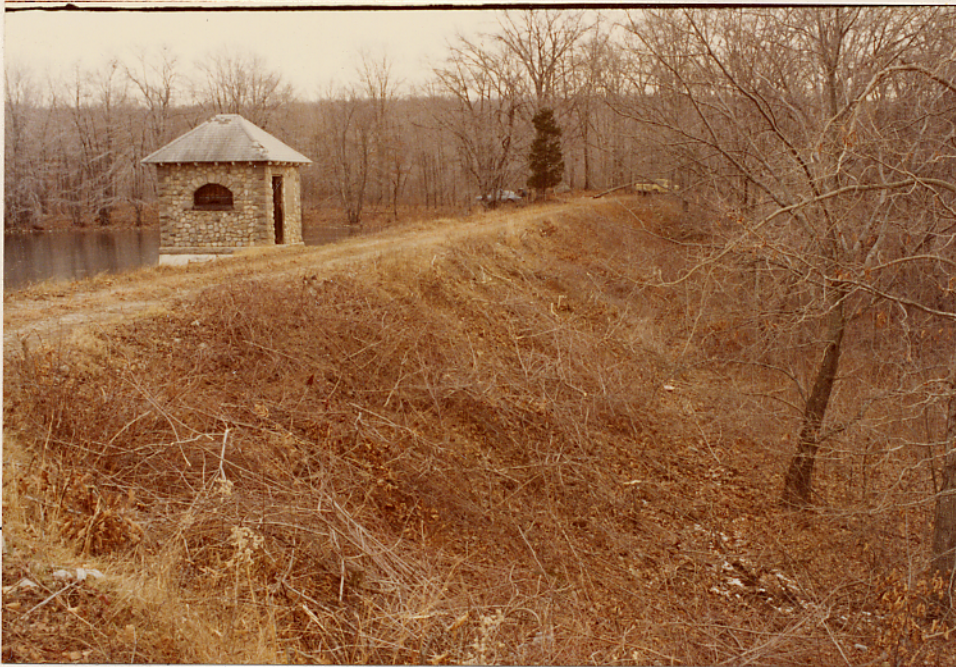
C-5 DOWNSTREAM SLOPE OF MAIN EMBANKMENT AT GATEHOUSE

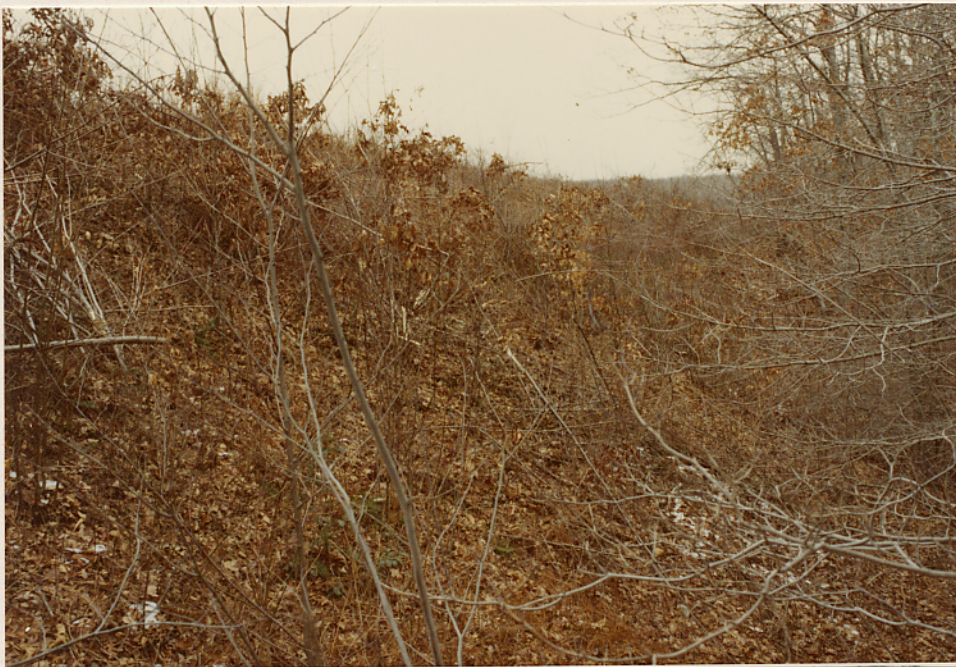
Trees and shrubs on the upstream and downstream slopes of the embankments can create future seepage problems. The tree roots provide seepage paths for water if allowed to grow. Uprooting of large trees can also cause serious "piping" problems by creating pathways through the embankments. An area should be cleared below the toe of the dam for approximately 30 feet in order to allow monitoring of seepage or discharges from the toe drains.

C-6 TYPICAL BRUSH OVERGROWTH ON DOWNSTREAM SLOPE OF MAIN EMBANKMENT

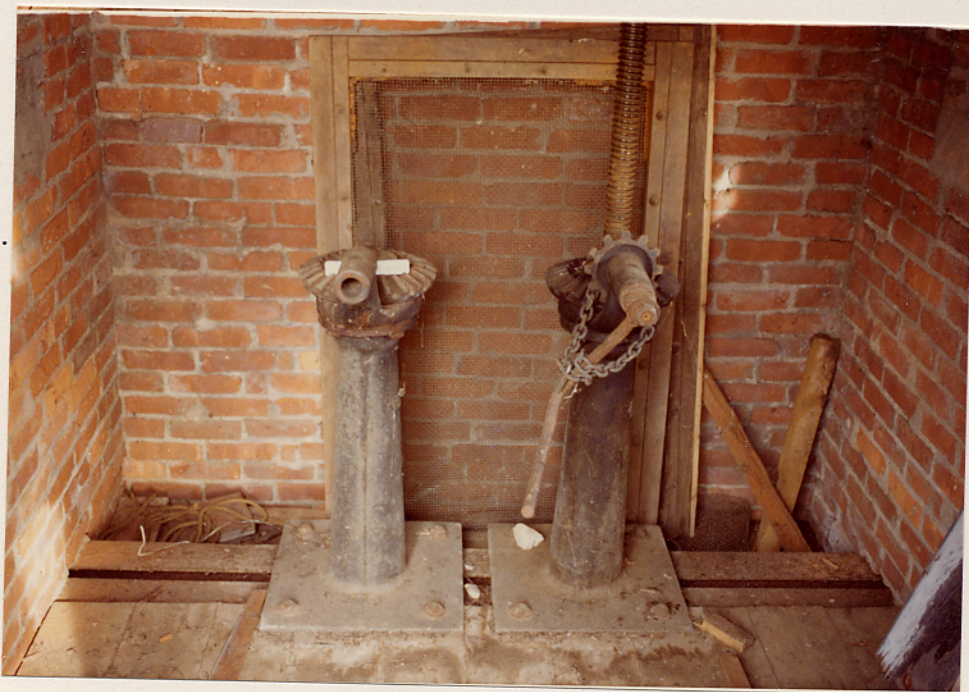
The outlet conduit is a 24-inch diameter (extra strength) cast iron pipe. The approach channel to the wet well was underwater and hence not observable. Water was being withdrawn from the reservoir at the time of the inspection through one intake only, the other intake was noted as inoperable (See Photo C-8).

4.3 Maintenance of the Operating Facilities. At the time of the inspection one gate at the control tower was open and water was flowing to the pumping station below the dam; however, the second gate was reportedly broken and inoperable. It is unknown if the inoperable gate is the upper or lower inlet. Water department personnel periodically exercise the valve below the dam to discharge water back to the stream.

C-8 INTERIOR OF GATEHOUSE

Repairs to the outlet works control gates should be implemented to provide maximum regulation of the pool water surface for operation and maintenance purposes.

4. Repair the inoperable gate at the control tower to assure the continued ability to regulate the water surface for maintenance purposes and to provide a water supply to the system.
5. Continue the technical inspection of this facility on an annual frequency.

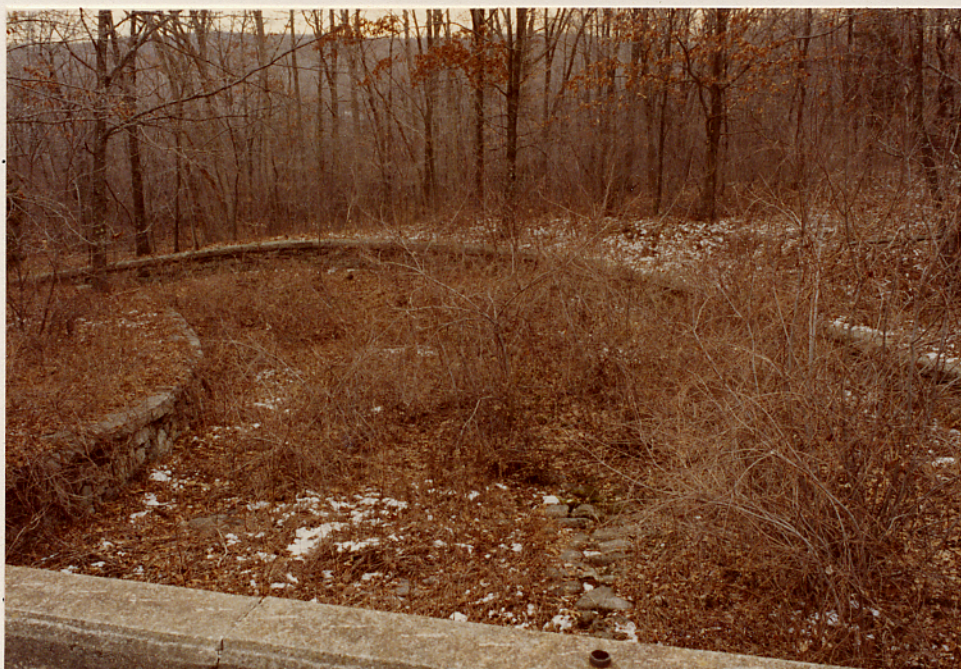
Water was flowing beneath the spillway bed at the point of tangency of the curved training wall. This flow apparently is seepage leaking through the spillway structure. At the downstream end of the chute at the stilling basin, the training wall stone work on both sides was in disrepair.

C-10 CONVERGING CURVED CHUTE OF SPILLWAY - LOOKING FROM SERVICE BRIDGE

The seepage noted beneath the spillway chute slab should be investigated further to determine its source, magnitude and corrective measures required.

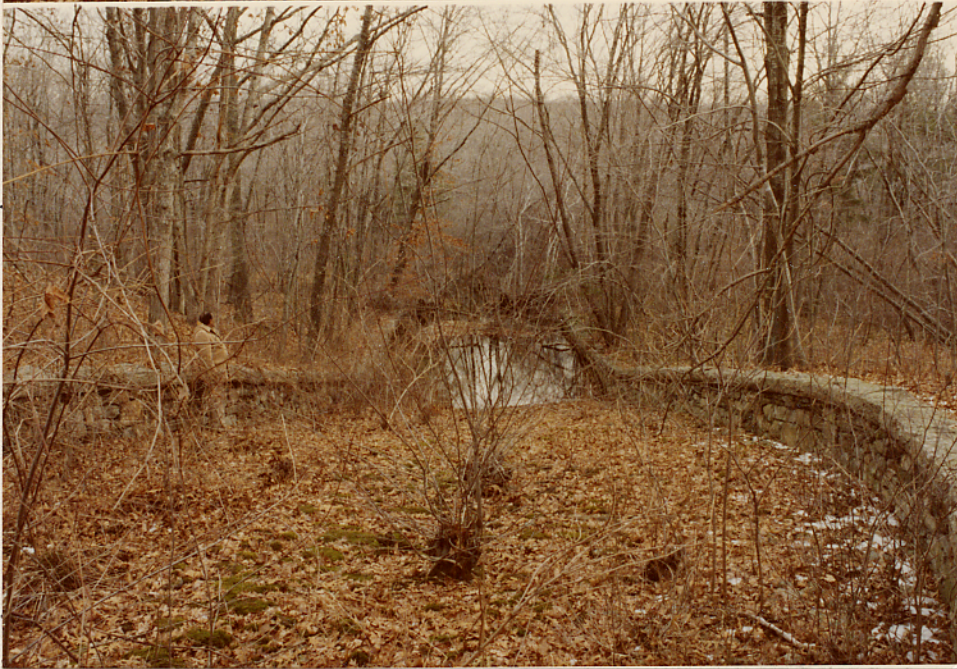
C-11 DOWNSTREAM CHUTE OF SPILLWAY

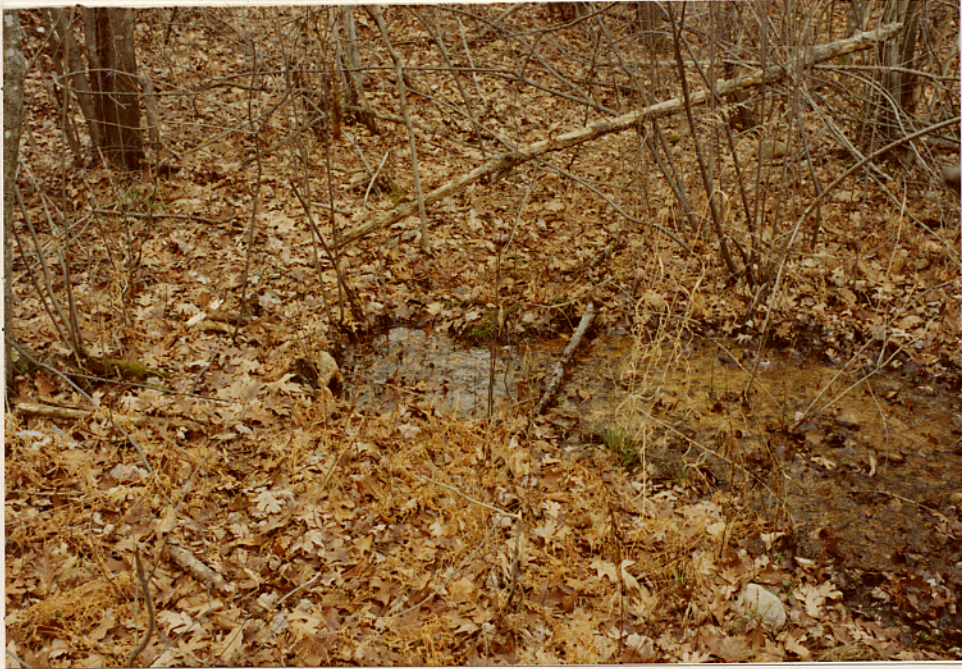
The discharges observed near the downstream toe of the main dam and dike showed some evidence of sediment transport and warrant further investigation. The possible association of these discharges with the toe drain outlets indicated in the plans needs to be verified.

C-13 TOE DRAIN OUTLET OF MAIN EMBANKMENT

- a. The discharges observed near the downstream toe of the main dam and dike should be investigated immediately by the Owner to verify the possible association of the discharges with the toe drain outlets indicated on the plans. If the discharge is outflow from toe drains, these toe drains should be extended in order that their discharges will exit above grade and they should be monitored. If the discharges are not associated with the toe drain outlets, then the source of the flows must be investigated and appropriate recommendations developed. The investigation should also determine the quantity of seepage and turbidity associated with the discharges.

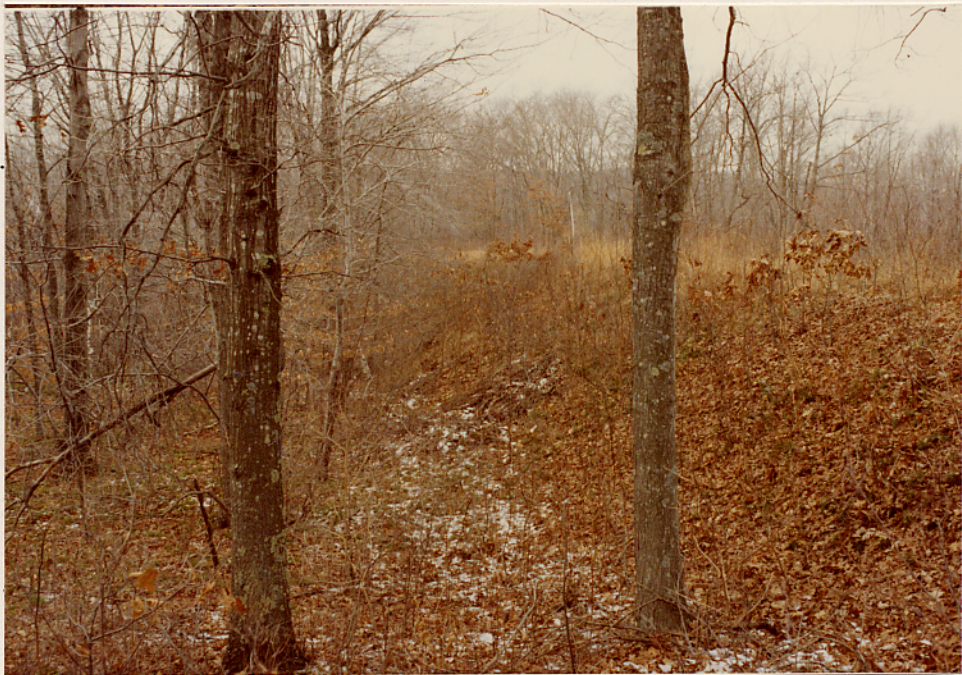
3. Downstream Slope. The downstream slope of the dike is 1.5H:1V and densely covered with brush and small trees. At the toe near the approximate center of the embankment a large seepage pond exists about at the location that the record plans indicate the outlet for a 6-inch diameter tile toe drain. This ponding could be the result of that outlet. There was no apparent sloughing of the slope noted and the slope appeared to have a reasonable line and grade without depressions or undulations. (See Photo C-16). A flowing discharge was observed during the second inspection at about Sta. 15+52 approximately 7 ft. from the toe of the slope. The discharge was about 1 ft. in diameter and contained trace amounts of sand and freshly deposited sand was found surrounding the area. Plans indicate a toe drain outlet is located in this area and the discharge may be associated with a toe drain outlet buried below the ground surface; however, no direct evidence of the existence of a drain outlet was visible in the field.

C-16 DOWNSTREAM SLOPE OF EAST DIKE - LOOKING FROM LEFT
ABUTMENT
